## Wood Treatment Compatibility with Insulating Glass Sealants

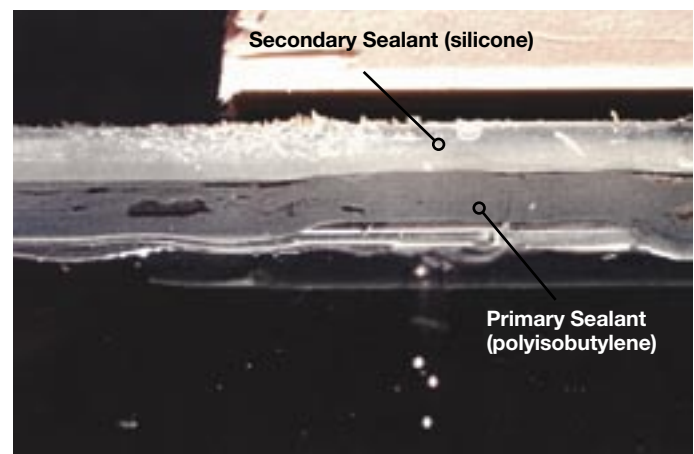
permitted to remain in the treatment tank for an extended period of time, solvents can remain in the lineal parts. In the tightly sealed reglet of a wood sash, the remaining solvent is trapped, and when exposed to high temperatures it can volatilize - with subsequent attack to the insulating glass edge seals. The same phenomena can occur with solvent laced glazing sealants and paints/varnishes. The solvents (naphtha & mineral spirits) that are not removed from the wood in the drying process can cause the problem with the insulating glass seals.

Fig. IG16-1. Effects of wood preservative solvents on insulating glass primary seal. Primary seal (polyisobutylene) shows softening, slumping, and chemical breakdown.

- Window manufacturers need to have good quality assurance to ensure complete drying of their window lineal parts.
- Glazing sealants that are high in petroleum-based solvents are not recommended (check with Cardinal R&D).
- Protection of the glazing reglet of the window sash should be made to eliminate rundown from paint, stain and varnish solutions.

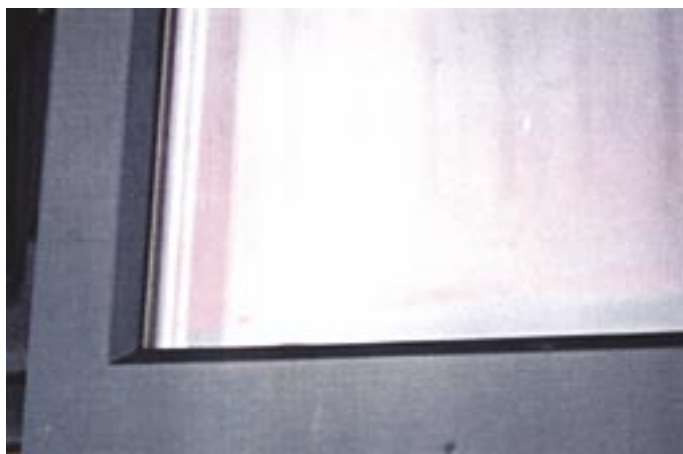
Fig. IG16-2. Photograph showing chemical fogging of low-E IG unit. Solvent vapors on the low-E coating results in a purple color when viewed in reflected light.

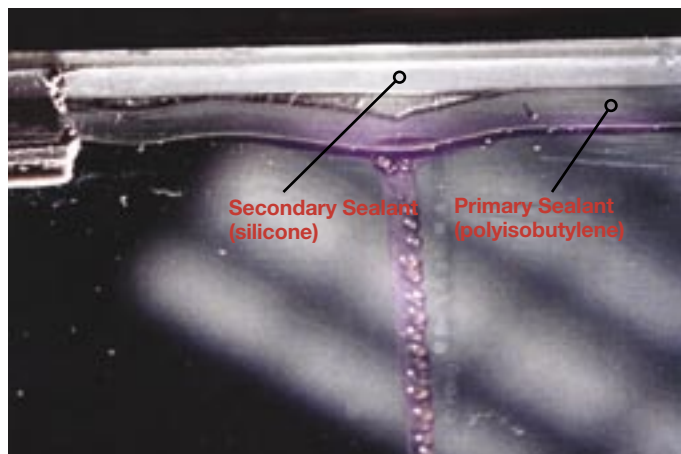
The vapors from petroleum-based solvents such as those found in wood preservatives, glazing sealants and wood stains/varnishes can permeate through the seals of insulating glass units, fabricated with hot melt butyl, polysulfide, polyurethane and/or silicone sealants. With dual-seal insulating glass units, the vapors can permeate through the secondary sealants and attack the primary sealant (polyisobutylene) of the insulating glass unit. Symptoms of solvent-based attacks of the primary sealant are slumping of the polyisobutylene (PIB) material into the airspace, spacer read-through, and in severe cases separation of the carbon black fillers from the PIB, as shown in Fig. IG16-1. The separation results in a clear thick liquid (drool) running down the glass, as seen in Figs. IG16-3 & IG16-4.

Fig. IG16-4. Close-up photograph of PIB drool, from exposure to petroleum-based solvents.

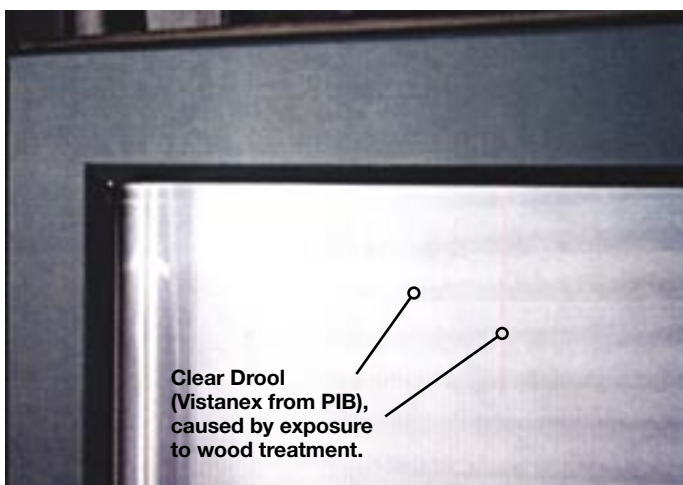
Fig. IG16-3. Photograph showing clear liquid (drool) running down the glass. Drool appears purple in color because of contact with low-E coating.
