# Edge Deletion of Sputtered Low-E Coatings

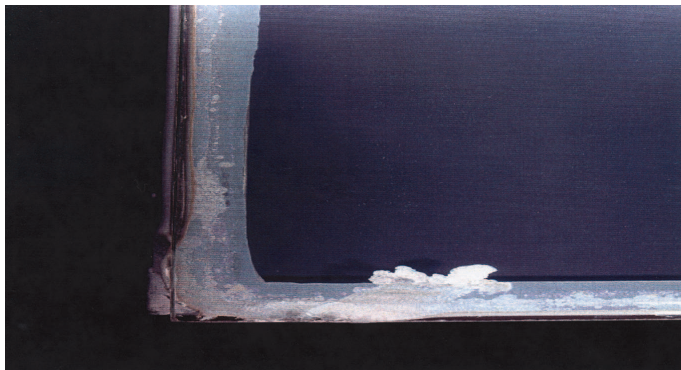
Fig. CG01-3: Coating Corrosion at Edge

Significant corrosion of the silver in the low-E coating was visible after 4 weeks of this test (as can be seen in Fig. CG01-3). The failure mechanism involved corrosion beginning at the edge and then progressing into the silicone secondary seal, through the primary PIB seal and into the viewing area of the IG unit. The corrosion and failure mechanism are important because butyl materials are considered to be the best IG sealant materials when it comes to resisting moisture permeation. Since the PIB primary seal did not stop the corrosion of the low-E coating, corrosion of low-E coatings will most likely occur with any other sealant material when exposed to the same test conditions.

It is recommended that the low-E coating be completely deleted around the periphery of the glass, as shown in Fig. CG01-4. Since the low-E coating contains multiple coating layers, all layers should be removed to ensure adequate and consistent adhesion of the sealants. The coating should be deleted using an edge grinding technique that removes all of the coating down to the glass surface. The deletion should reach to a height that does not contact the sealant(s) or, in a dual-seal system, to a minimum of half the primary sealant height.

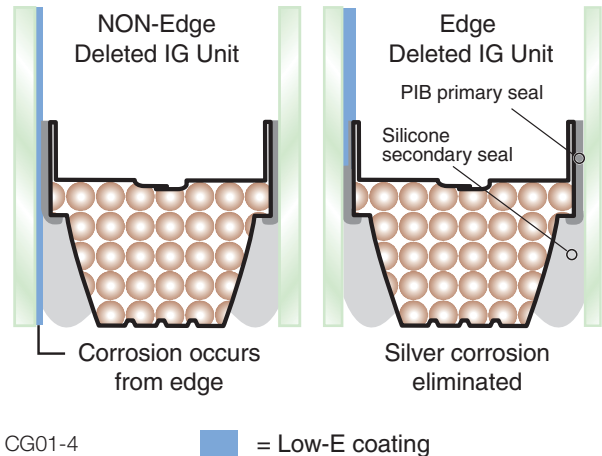
Fig. CG01-4

As shown in Fig. CG01-4, corrosion occurs from the edge of the glass because the silver in the coating stack is completely exposed. Testing has indicated this will occur in single or double silver coating stacks; however, since there is less silver in the single silver layer stack, corrosion will most likely take longer to occur.
