Insulating Glass Breakage

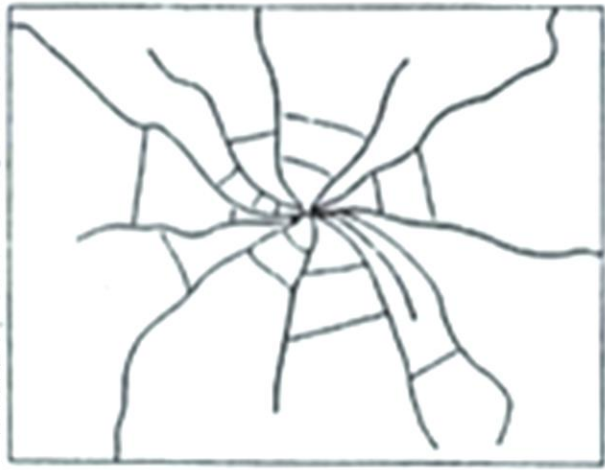
Fig IG24-1: Impact Pattern

A typical impact breakage pattern is shown in Figure IG24-1. Due to the small particle size when glass fractures from impact, the glass may evacuate the opening which can conceal the fracture pattern.

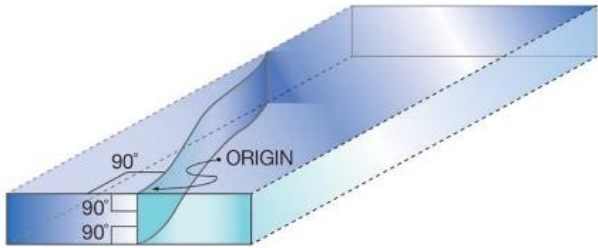
Fig IG24-2: Thermal Stress

A typical breakage pattern from thermal stress is shown in Figure IG24-2 and is caused by the glass not being able to sustain the thermal conditions experienced at the installation site. Conditions that can produce thermal breakage of glass panes can be related to, but not limited to, a combination of the following: high absorption glass products, outdoor overhangs, indoor shading (blinds, draperies, etc.) size of the window, and flaws at the glass edge.

One typical case for thermal breakage is the use of solar absorbing glass or coatings on the room side of the IG unit. They raise the central glass temperature on the room side pane, while the glass edges remain cold. This temperature gradient produces thermal stress in the room side glass pane and if there are any significant edge flaws, thermal breakage could take place initiating at the flaw. Thermal break patterns generally occur at 90 degrees to the edge of glass. Additional thermal breakage information can be found in TSB IG07. The use of heat strengthened and tempered glass will virtually eliminate the chance of thermal breakage.

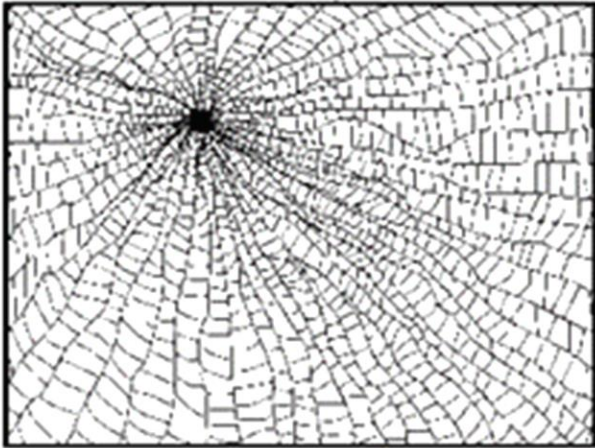
Fig IG24-5: Tempered

A typical breakage pattern for tempered glass is shown in Figure IG24-5. Tempered glass is classified as a safety glazing material because when it fractures it breaks into relatively harmless fragments with no jagged edges or shards.

All glass products have some level of inclusions i.e. seeds, bubbles, and stones which are an unavoidable part of the glass forming process. These inclusions are controlled to minimum levels and usually are not visible to the naked eye. One type of a very rare inclusion is called a nickel sulfide stone. This particular type of stone may undergo a phase transformation (shrink) in tempered glass due to the re-heat/quench operation. Over a period of time, these particles will tend to revert back to their original state (expand). This phase transformation can cause tempered glass to fracture spontaneously, but this is

a rare occurrence. Annealed and heat-strengthened glass will not have fractures from inclusions i.e. nickel sulfide stones.

Naturally, any glass that has fractured in the field should be replaced. Breakage of tempered glass is rare because of its exceptional strength and impact resistance. Breakage that does occur with tempered glass usually occurs from impacts from lawn mower debris, stones, carpenter tools etc.
