# Insulating Glass Condensation

This service bulletin describes condensation on glass surfaces:

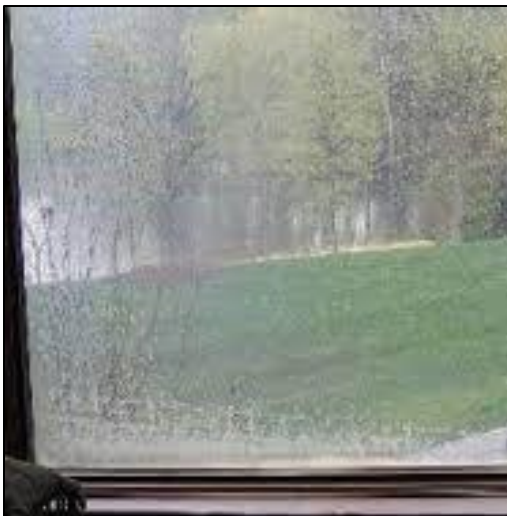
Fig 01-1: Airspace Condensation

Glass units should be replaced when condensation is evident in the airspace. Insulating glass units experiencing condensation in the airspace are usually due to a failure of the insulating glass seal. This is first evident in the wintertime when the outdoor temperatures are low causing a lower glass temperature and the potential for condensation to form (Fig 01-1). Airspace condensation can also be caused by a small crack in the glass that is sometimes not immediately evident. The outdoor and indoor glass surfaces should be cleaned to make certain the condensation is in the airspace and not on the outdoor or indoor glass surfaces.

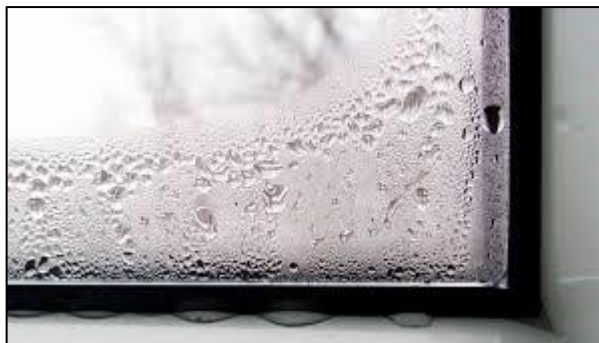
Fig 01-2: Interior Glass Condensation

Glass units having indoor condensation or sweating caused by high room side humidity conditions should not be replaced. This phenomenon is usually seen in the winter at the bottom edge of the glass (Fig 01-2), around the glass periphery, or sometimes on the complete indoor glass surface. It is caused by high room side humidity conditions when the indoor glass temperature is below the dew point of the room side air.

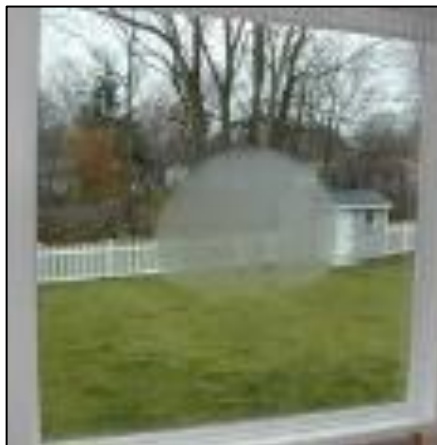
Fig 01-3: Condensation Ring

Glass units having indoor center condensation rings should be evaluated. When insulating glass unit panes are touching in the center, wintertime indoor condensation rings can be seen in the center of the glass (Fig 01-3). These rings may be circular or elliptical depending on the window shape (square, rectangular, circle, top, etc.)

Condensation rings occur when the glass lites touch in the glass center because there is a reduced insulating value and the indoor glass temperatures are closer to the outdoor glass temperatures. This increases the potential for condensation on the room side pane and becomes evident when the room side glass temperatures fall below the dew point temperature of the room side air. The condensation only occurs in the center of the glass because the spacer keeps the edges of the glass apart maintaining the airspace's insulating properties.

It is suggested that the window or glass manufacturer be contacted to confirm that the glass is indeed touching in the center. Condensation at the center of the unit can also occur if the room side humidity levels are high. In addition, the use of bars and grilles in between the glass panes can result in the bars touching the glass and creating a cold surface, resulting in the formation of condensation where these bars are located in the IG unit (see TSB #IG08 "Use of Internal Grilles" for details). If the glass is touching in the center, repair or replacement of the glass may be required.

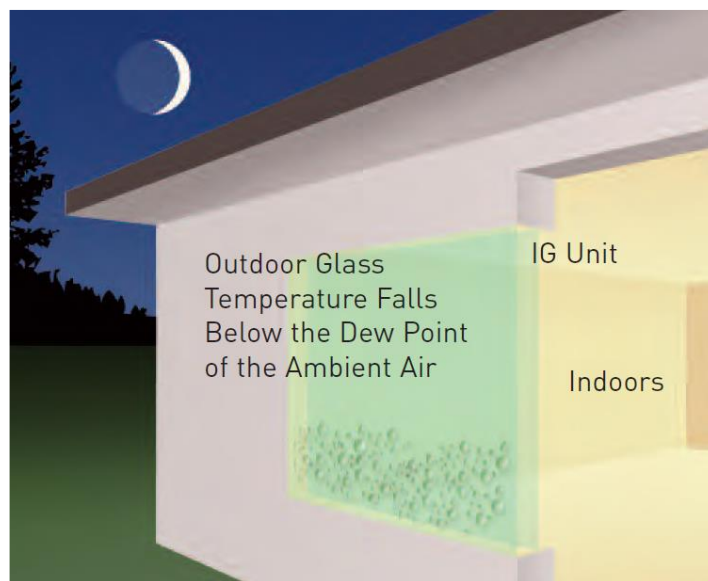
Fig 01-4: Outdoor Condensation

Glass units should not be replaced for complaints or concerns when outdoor condensation occurs. Condensation on the outdoor glass surface of an insulating unit is not an indication that the glass or insulating unit is defective. Under the right set of atmospheric conditions it is possible to get condensation on the outdoor surface of an insulating glass unit. Specifically, these conditions are as follows:

Exposed to the above conditions, the outdoor glass surface can radiate heat away to the night sky, and with good insulating glass products the outdoor glass temperature can fall below the dew point of the ambient air. When this occurs, moisture from the air will condense on the outdoor glass surface (fig 01-4). Similarities of this condensation on glass products can be drawn to moisture or dew on lawns or on automobiles when exposed to the above mentioned natural occurring phenomena.
