Insulating Glass Condensation

This service bulletin describes condensation on glass surfaces:

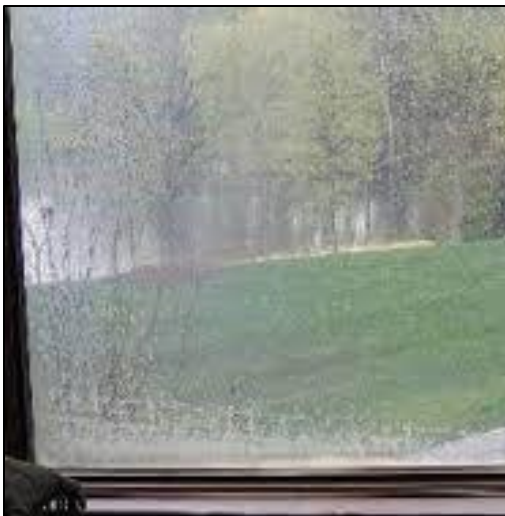
Fig 01-1: Airspace Condensation

Glass units should be replaced when condensation is evident in the airspace. Insulating glass units experiencing condensation in the airspace are usually due to a failure of the insulating glass seal. This is first evident in the wintertime when the outdoor temperatures are low causing a lower glass temperature and the potential for condensation to form (Fig 01-1). Airspace condensation can also be caused by a small crack in the glass that is sometimes not immediately evident. The outdoor and indoor glass surfaces should be cleaned to make certain the condensation is in the airspace and not on the outdoor or indoor glass surfaces.

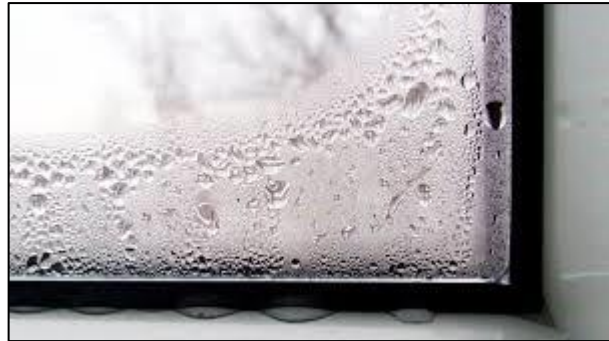
Fig 01-2: Interior Glass Condensation

Glass units having indoor condensation or sweating caused by high room side humidity conditions should not be replaced. This phenomenon is usually seen in the winter at the bottom edge of the glass (Fig 01-2), around the glass periphery, or sometimes on the complete indoor glass surface. It is caused by high room side humidity conditions when the indoor glass temperature is below the dew point of the room side air.

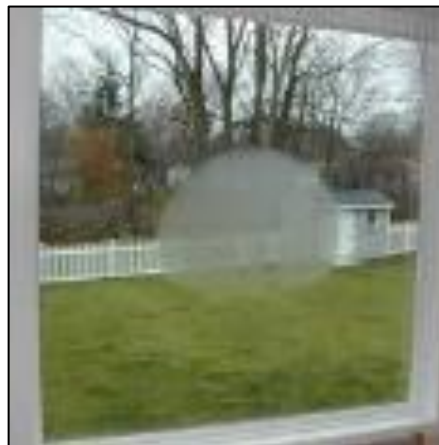
Fig 01-3: Condensation Ring

Glass units having indoor center condensation rings should be evaluated. When insulating glass unit panes are touching in the center, wintertime indoor condensation rings can be seen in the center of the glass (Fig 01-3). These rings may be circular or elliptical depending on the window shape (square, rectangular, circle, top, etc.)

Condensation rings occur when the glass lites touch in the glass center because there is a reduced insulating value and the indoor glass temperatures are closer to the outdoor glass temperatures. This increases the potential for condensation on the room side pane and becomes evident when the room side glass temperatures fall below the dew point temperature of the room side air. The condensation only occurs in the center of the glass because the spacer keeps the edges of the glass apart maintaining the airspace's insulating properties.

It is suggested that the window or glass manufacturer be contacted to confirm that the glass is indeed touching in the center. Condensation at the center of the unit can also occur if the room side humidity levels are high. In addition, the use of bars and grilles in between the glass panes can result in the bars touching the glass and creating a cold surface, resulting in the formation of condensation where these bars are located in the IG unit (see TSB #IG08 "Use of Internal Grilles" for details). If the glass is touching in the center, repair or replacement of the glass may be required.

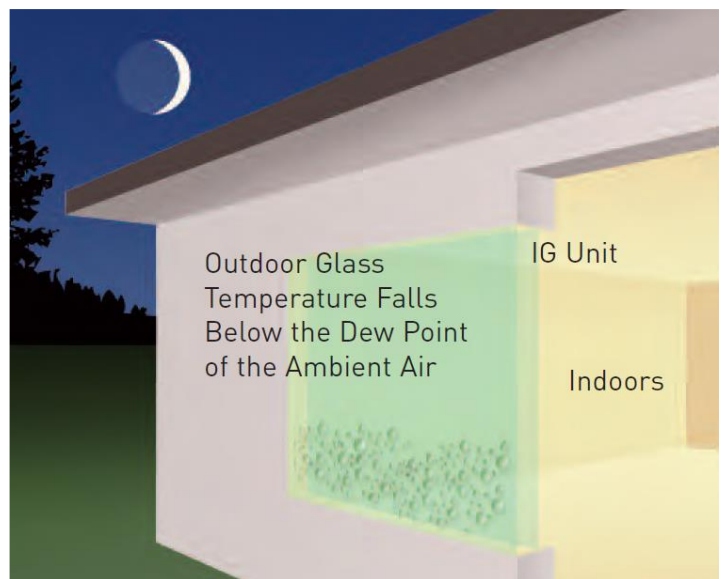
Fig 01-4: Outdoor Condensation

Glass units should not be replaced for complaints or concerns when outdoor condensation or frost occurs. Condensation on the outdoor glass surface of an insulating unit is not an indication that the glass or insulating unit is defective. Under the right set of atmospheric conditions it is possible to get condensation on the outdoor surface of an insulating glass unit. Specifically, these conditions are as follows:

Exposed to the above conditions, the outdoor glass surface can radiate heat away to the night sky, and with good insulating glass products the outdoor glass temperature can fall below the dew point of the ambient air. When this occurs, moisture from the air will condense on the outdoor glass surface (fig 01-4). Similarities of this condensation on glass products can be drawn to moisture or dew on lawns or on automobiles when exposed to the above mentioned natural occurring phenomena. In colder climates, it is not uncommon for the dew to freeze and form frost on the outside glass surface (similar to frost on a car's windshield).
