Capillary Tubes & Breather Tubes

CAPILLARY VS. BREATHER TUBES

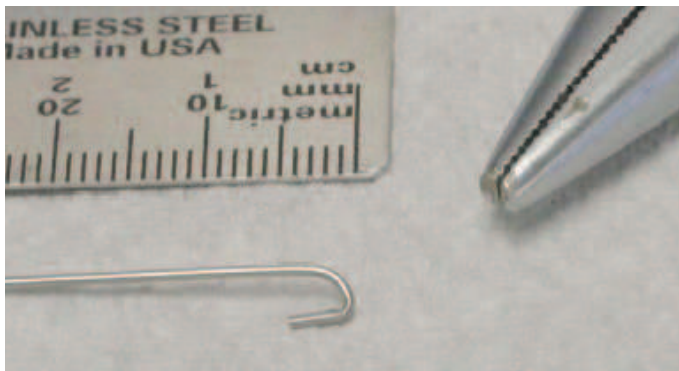
Capillary tube prior to insertion into the spacer.

Capillary tubes are small stainless steel or aluminum tubes with a typical inside diameter of 0.010 to 0.020 inches, and a typical length of 12 inches. Capillary tubes are typically left open in the field, which allows the IG unit to equalize initially and maintain a generally flat appearance over time. Cardinal IG uses only capillary tubes in high altitude applications.

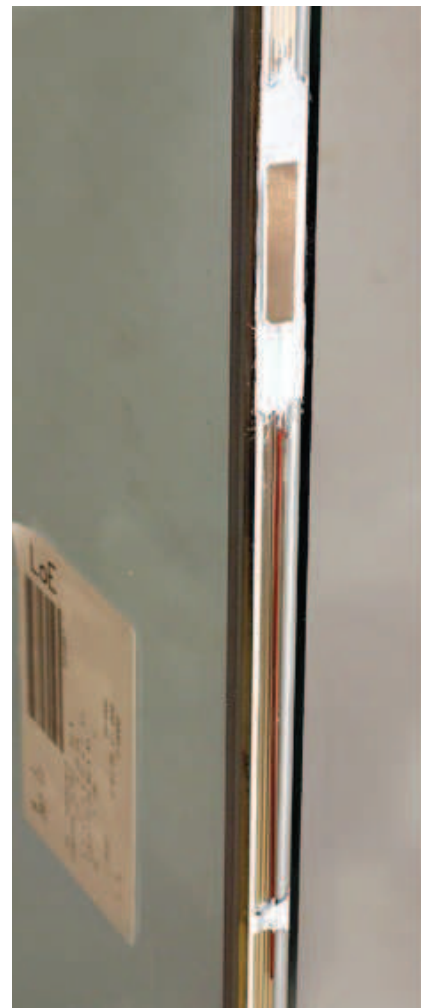
Installed capillary tube, colored red for photo only.
