Vinyl Siding Distortion

Instances of vinyl siding distortion have been reported along with questions related to how it occurs. This bulletin provides information related to a study and analysis conducted by Cardinal Glass Industries along with general recommendations on how to avoid vinyl siding distortion.

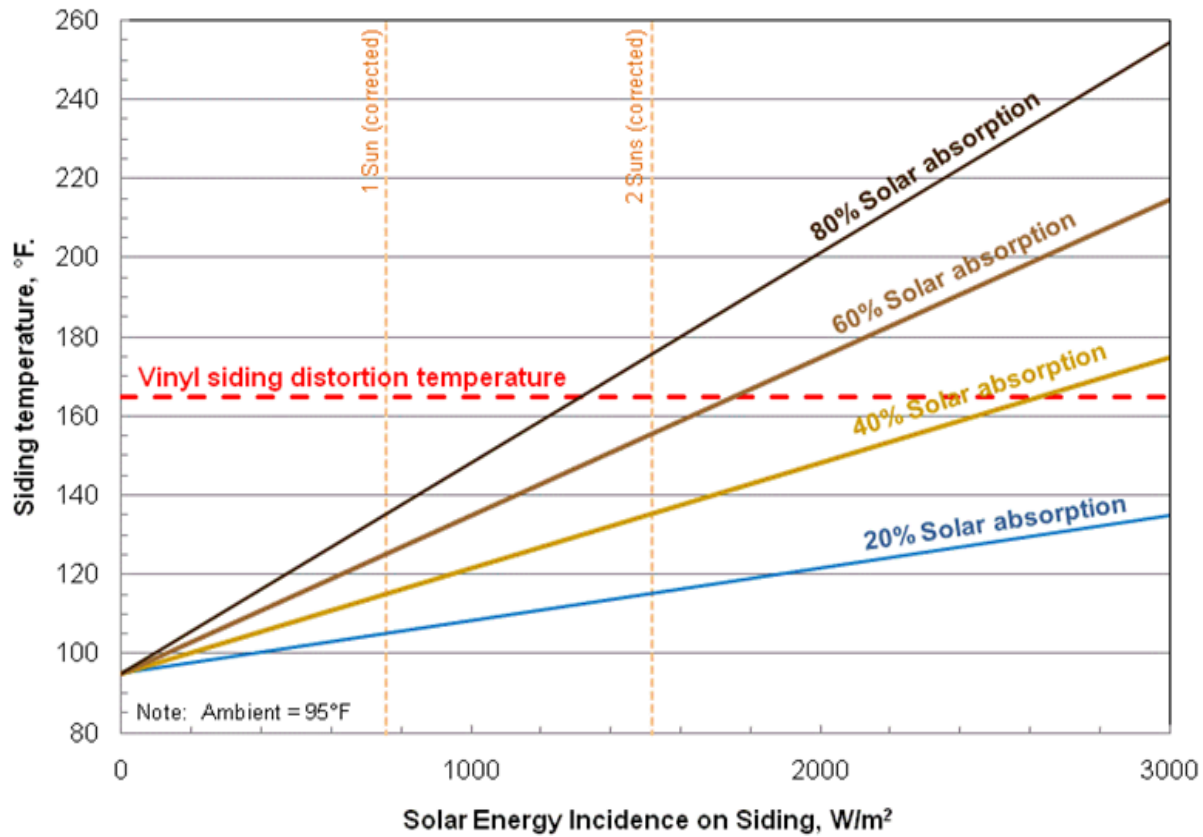
Figure 1. Temperature vs. Solar Irradiance

There is a direct correlation between vinyl siding solar absorptance and the heating of the vinyl siding above the ambient air temperature. Figure 1 shows surface temperature versus solar irradiance for four vinyl siding products at various solar absorptances (Clear, non-windy day, with an ambient air temperature of 95 °F).

½ Sun	1 Sun	1-1/2 Suns	2 Suns
Partly cloudy	Clear sunny day	Clear sunny day + ½ sun material reflection	Clear sunny day + 1 sun material reflection

With no sun on the siding, the vinyl siding temperature is the same as the ambient air temperature. At 20% and 40% solar absorptance, vinyl siding is able to withstand greater exposure to solar irradiance before distorting, than darker vinyl siding at 60% and 80% solar absorptance.

maximum test level of 120 °F. This is significantly below the temperature that vinyl siding can experience when exposed to direct sunlight. See Figure 1.

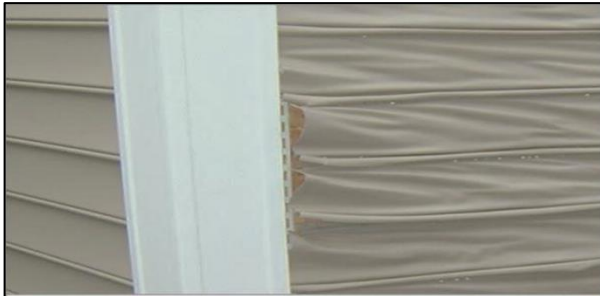
Figure 2. Vinyl Siding Distortion

All plastics relax at their glass transition temperature. Vinyl siding tends to shrink above this temperature. Consequently, when vinyl siding is heated to its glass transition temperature after installation, the frozen-in strains relax, creating buckling and wrinkles as shown in Figure 2. The figure also demonstrates how white vinyl products (with a lower absorptance) perform better when exposed to the same solar energy. Notably, the white vinyl corner shown in Figure 2 has not distorted, while the adjacent darker siding has visibly distorted.

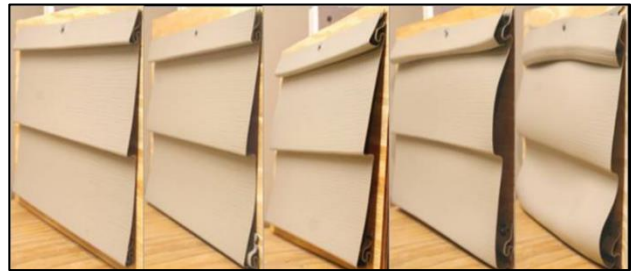
predict the behavior of the plastic over time. Like other plastics, the modulus of vinyl siding is time and temperature dependent. Figure 3 shows the appearance of PVC vinyl siding specimens (0.038 inch thick) after being heated for one hour in an oven at four different temperatures (160 °F, 165 °F, 170 °F and 180 °F). After one hour of exposure to 165 °F of heat, vinyl siding visibly distorts.

Not heated (A) 160 °F (B) 165 °F (C) 170 °F (D) 180 °F
Figure 3. Vinyl Siding Heated for One Hour

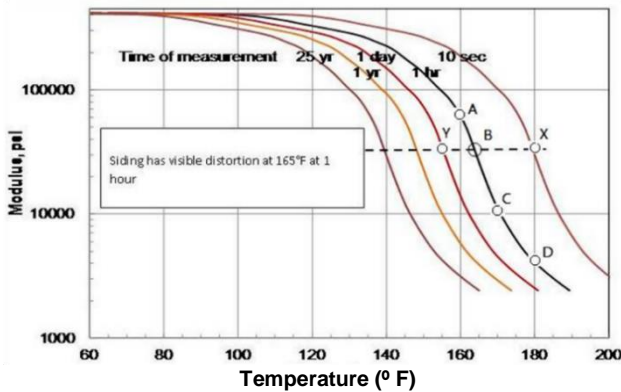
Figure 4. Vinyl Siding Modulus vs. Temperature with Respect to Time

The time-temperature superposition principle can also be used to predict when the same amount of relaxation and distortion will occur at other times and temperatures. The dashed line in Figure 4 shows that one hour of exposure at 165 °F (B) is equivalent to a ten second exposure at 180 °F (X) and a one-day exposure at 155 °F (Y).

The modulus of vinyl siding (material stiffness and rigidity) is time dependent. The time-temperature superposition principle is used for all plastic materials and Figure 4 above shows the modulus of vinyl siding vs. temperature with respect to time. Plastic materials relax more as the modulus is lower. The vinyl siding product tested relaxed and distorted visibly when subjected to 165 °F for 1 hour as indicated by point “B” in Figure 4.

The information from Figure 4 is further summarized in Figure 5 to demonstrate how the interplay between exposure time and exposure temperature impacts the appearance of the vinyl siding. The exposure over time is cumulative. While the sun’s energy may strike a particular section of vinyl siding only for a short time each day, when repeated on a daily basis, the molecular bonds of the siding are further degraded each day. Therefore, exposure for one hour at 165 °F is equivalent to ten minutes of exposure, repeated for six consecutive days, at 165 °F.

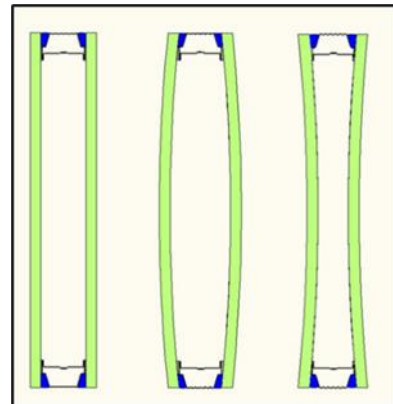
Figure 7. Dynamic Flexing

Figure 7 shows the dynamic flexing of insulating glass lites that may be seen in an insulating glass unit due to temperature and pressure changes in the environment. Most insulating glass units do not flex as much as indicated in the illustration. It is shown for illustrative purposes only.

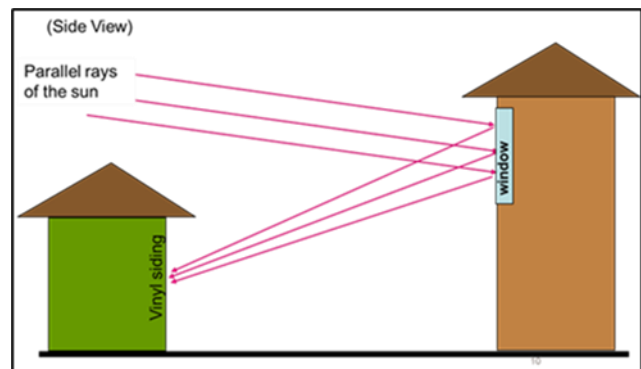
Figure 8. Opposite Wall

Figures 8 and 9 illustrate how the sun’s energy can be reflected off a window or door onto vinyl siding installed on an opposing wall of a neighboring structure (“opposite wall condition”). In this scenario, the solar energy is reflecting off the glass of the insulating glass unit.

When solar energy is reflected off an insulating glass unit with no or minimal deflection, the resulting reflection stays in relatively parallel lines and does not concentrate. As the amount of deflection increases, the reflected energy becomes more concentrated, resulting in higher temperatures where the light rays converge. As noted previously, some glass deflection is expected due to environmental changes.

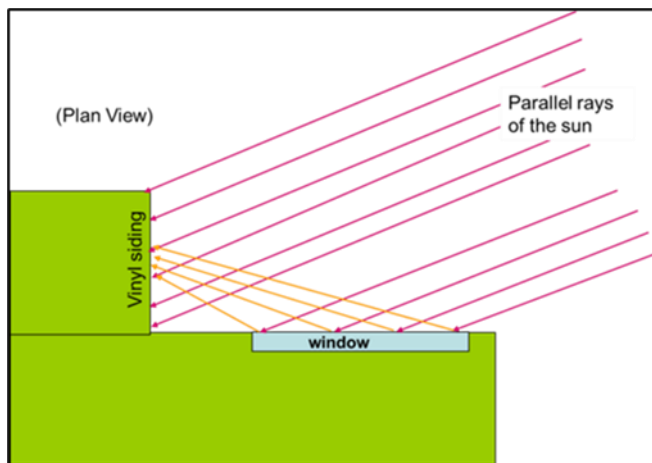
Figure 10. Inside Corner

Figures 10 and 11 illustrate how a vinyl siding clad inside corner can be exposed to solar energy. In this situation, the vinyl siding receives direct exposure to the sun's energy. In addition, sun may reflect off an adjacent glass product at a grazing angle onto the vinyl siding. This results in a near doubling of the solar exposure on the vinyl siding.

The inside corner condition occurs when the sun's rays reflect off a glass product at a very small grazing angle. In this scenario, the solar energy is generally reflecting off the first surface (i.e. outer surface of the exterior lite of glass) of an insulating glass unit. The reflection associated with Figure 11 came from the upper sash of a clear, uncoated dual pane window that did not have a screen on it. Small grazing angle reflections will usually result in the same amount of reflected energy from windows containing a Low-E coating as from windows with clear uncoated glass.

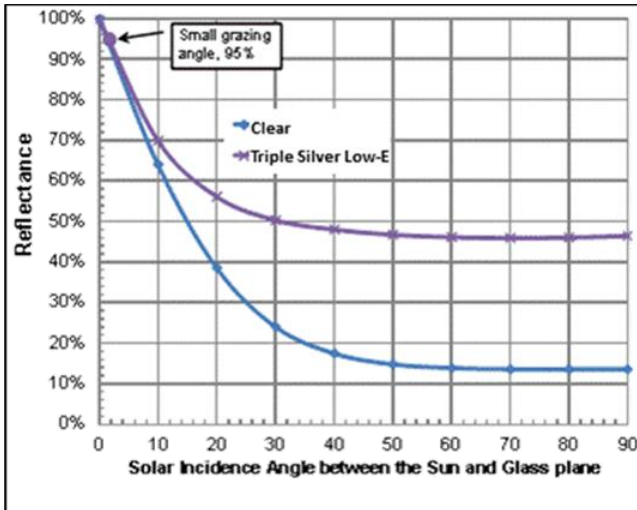
Figure 12. Reflectance at Grazing Angle

At a grazing angle (<math><10^\circ</math>), the reflectance off clear glass is essentially the same as the reflectance off Low-E coated glass. Figure 12 shows how the solar incidence angle between the sun and glass pane impacts the resulting reflectance. As the incidence angle approaches 0° (grazing angle), the reflectance for clear glass and Low-E glass approaches 100%.

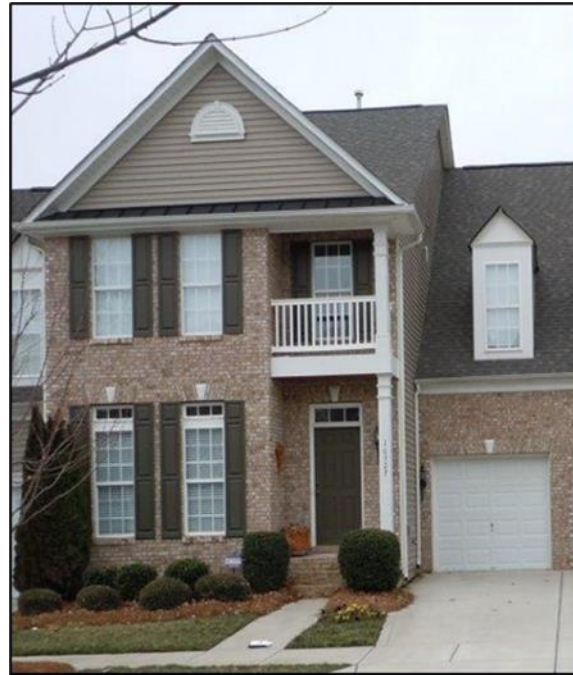
Figure 13

An inside corner condition with vinyl siding distortion was observed during the study of a residential development in North Carolina. Vinyl siding with 65% absorptance was installed throughout the development. The windows in the development contained insulating glass units with two lites of clear glass. Distortion was observed on an inside corner where the vinyl siding was subjected to direct solar energy and energy reflected at a grazing angle off the glass of the upper sash of a single hung window.

Figures 13 and 14 depict the inside corner condition and distortion observed. Note the dark shingles adjacent to the distorted area. The shingles likely contributed to increasing the overall temperature of the vinyl siding through infrared radiation and warm air convection from the hot shingles.

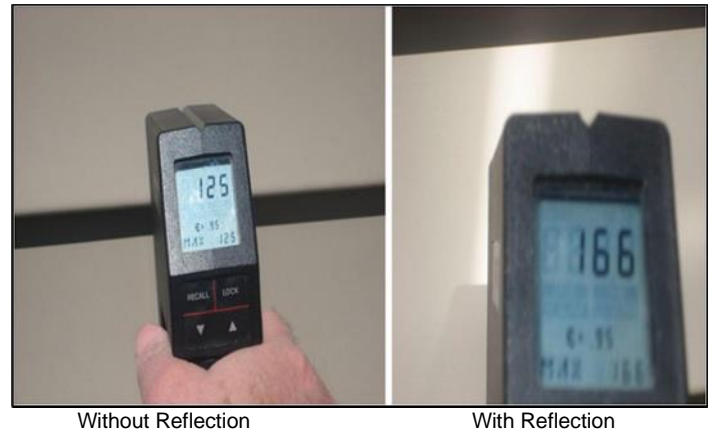
Figure 15. Siding Temperatures

- Outdoor air temperature: 75 °F
- Siding absorptance: 65%
- Thickness of siding: 0.038"
- Color of Siding: Tan
- Angle of siding: 7° from vertical
- Window type: Single hung, no screen
- Glass dimensions: 27" W x 30.5" H
- IG unit construction: 2.2mm clear glass/ 11mm airspace / 2.2 mm clear glass
- Airspace gap reduction: 0.132" (~1/8")
- Glass deflection: 0.066" (~1/16")
- Distance from center of glass (upper sash) to siding distortion: 87" to top of distortion, 116" to bottom
- Other radiating/reflective surfaces: Roof
- Color of the roof: Black
- Solar irradiance on siding without reflectance: 759 W/m² (corrected for 7° slope from vertical wall)
- Solar irradiance on siding with reflectance: >1,766 W/m² (corrected for 7° slope from vertical wall)
- Siding temperature direct sun w/o reflections: 125 °F
- Siding temperature direct sun w/ reflections: 166 °F

Note that these conditions show that the siding temperature can get hot enough to produce visible vinyl siding distortion. The temperature readings are shown in Figure 15.

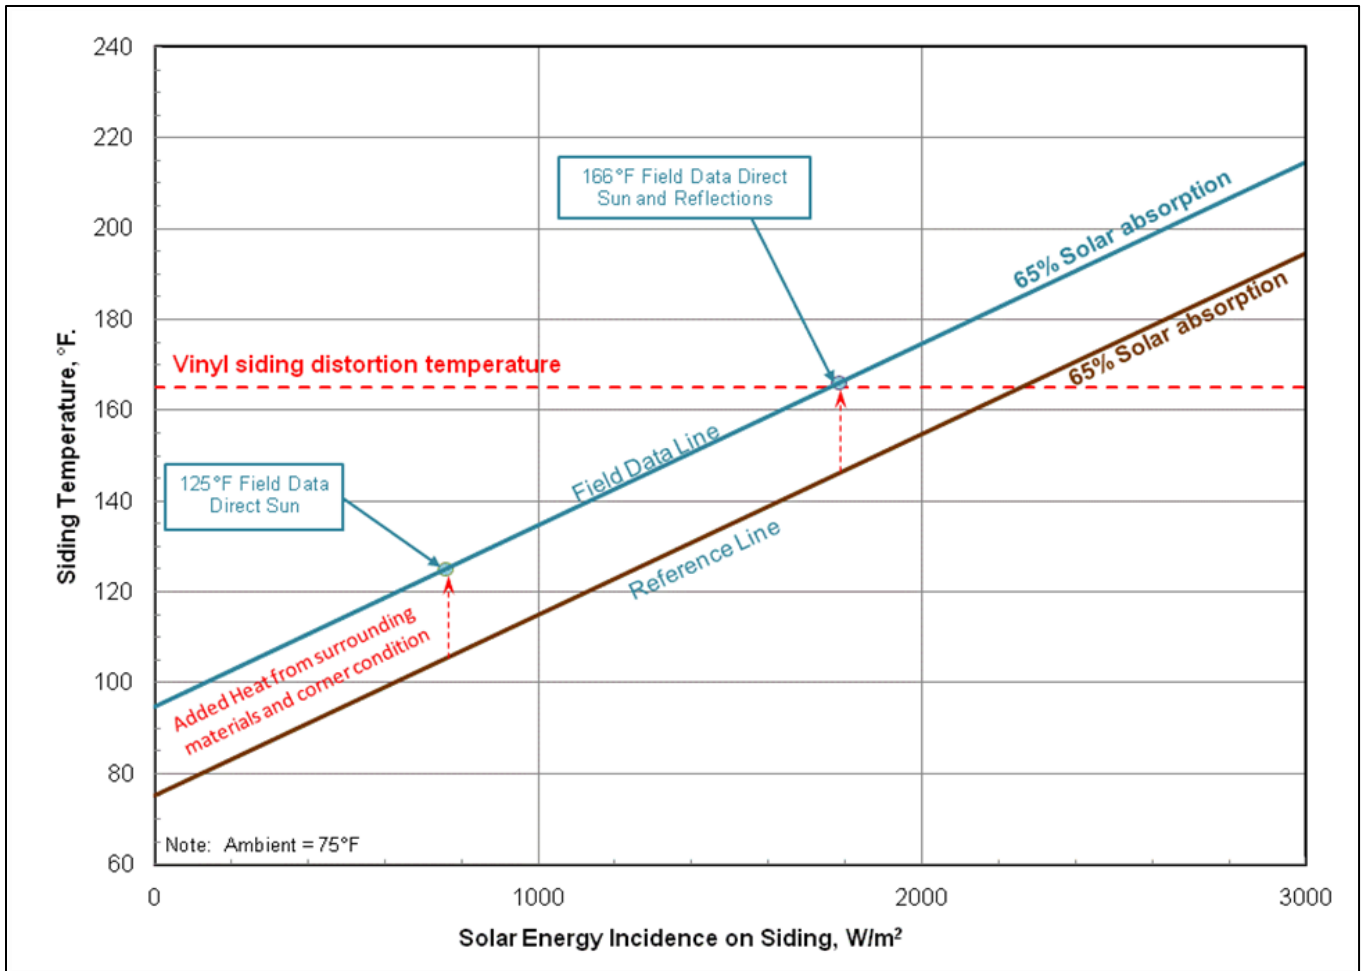
Figure 16. Field Measurements of Siding Temperatures vs. Irradiance

Figure 16 shows the siding temperature versus solar irradiance for a siding with 65% absorptance. Note that there are two plots; one for the field data from the North Carolina project, and one based on projected temperatures from an analysis similar to Figure 1. The higher temperatures in the field data plot can be attributed to the influence of additional heat generated on the siding by the dark shingled roof, reflection of solar energy off of adjacent siding, and the trapping of heat due to the geometry of the inside corner condition. The other plot does not include these other heat sources in the projected temperatures.

In this case, the data shows that at an inside corner condition, with grazing angle reflections from clear glass and adjacent siding, along with additional heat generated from other building materials were conditions present when vinyl siding distortion occurred.
