Fogging Potential in Insulating Glass Units

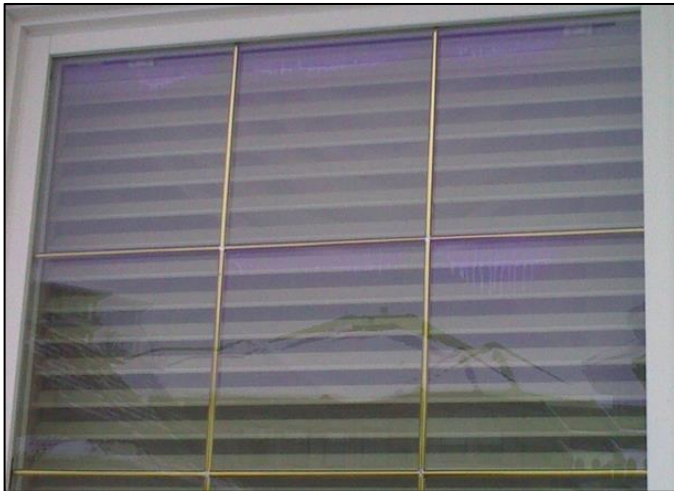
Chemical fogging can look similar to condensation in the airspaces. Typically, it is more apparent in IG units with LoE™ coatings and will not dissipate. It is often caused by a temperature differential being applied over the unit. This can be caused by shadow patterns like those from building overhangs (Fig. 10-1).

Fig. 10-1: Chemical fogging as seen in a non-Cardinal IG produced unit. Chemical can be seen running down glass in area of internal grilles

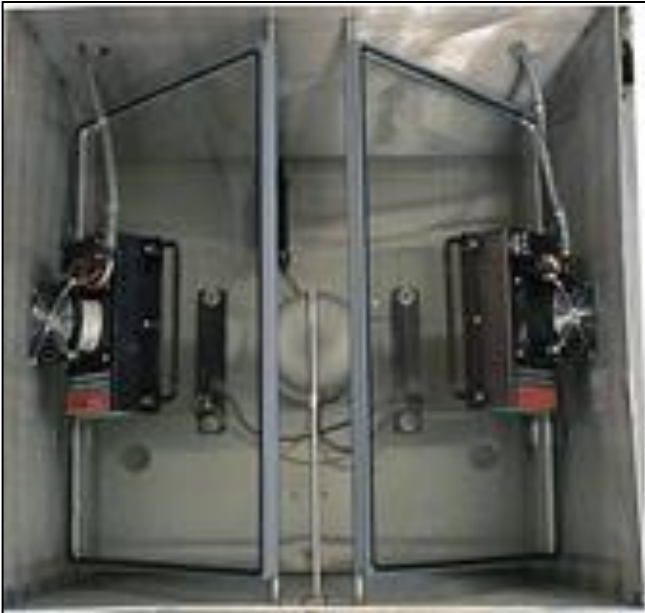
In Cardinal's Fog Box test (fig. 10-2), a unit is tested for one week at 140° F with constant UV light and a 7 in² cold plate at 70° F. After this exposure, the unit is inspected in both transmission and reflection to determine if a volatile fog is present. If present the fog is rated on a scale of 1 to 5.

Fig. 10-2: View inside a Cardinal Fog Box

The rating system for fog in the Cardinal Fog Box Test is as follows:

1. Faint fog with no defined outline, little to no color
2. More visible fog, with no defined outline, possible color
3. Heavy fog with crisp outline of condenser plate, possibly multicolored
4. Heavy fog with liquid droplets (that may run if unit tilted vertically), obvious outline of the cold plate, potentially multicolored
5. Heavy fog with crystalline deposits, liquid droplets possible (that may run if unit tilted vertically), obvious outline of the cold plate, potentially multicolored
